ST. LAWRENCE RIVER BASIN

# CRANBERRY LAKE DAM

## PHASE I INSPECTION REPORT NATIONAL DAM SAFETY PROGRAM

NY 00397

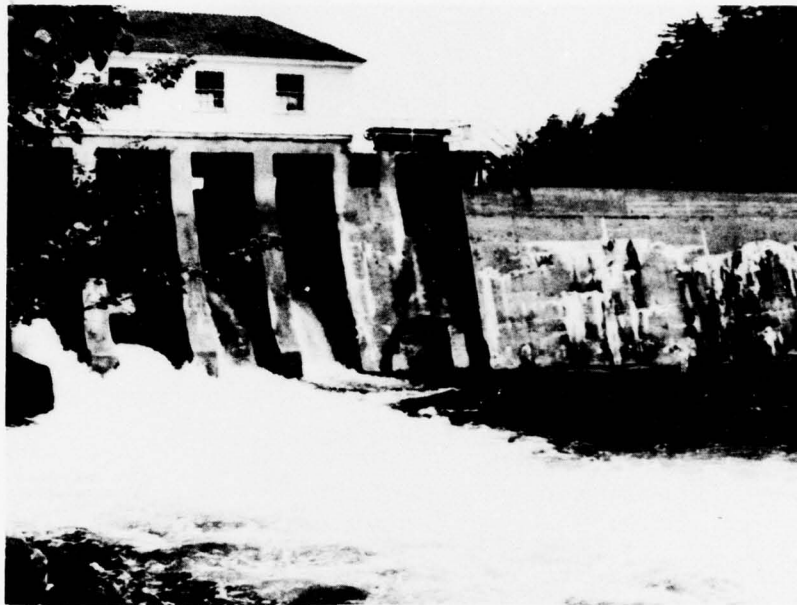
OVERALL VIEW OF DAM

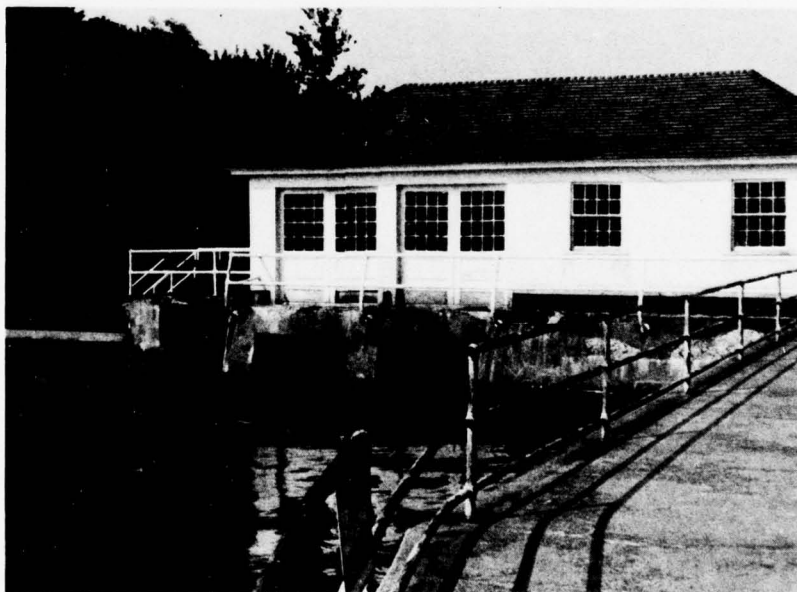
GATE HOUSE

The downstream face of the gatehouse and sluiceway is protected with a gunite surface treatment. The gunite surfacing has cracked over most of this area and spalled concrete was noted in a few of the areas where the gunite had scaled from the structure. Severe erosion of the gunite is evident at the base of the piers separating the individual gates and stoplog slots.

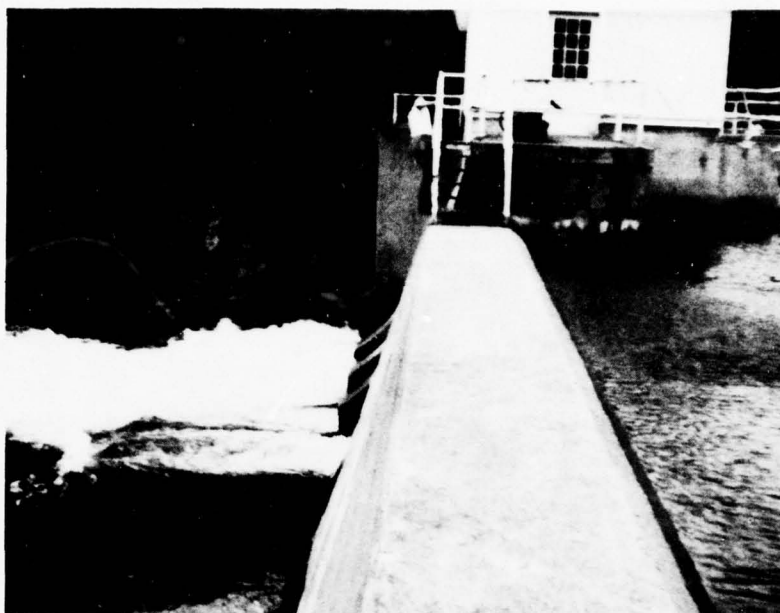
d. Spillway - The upstream slope of the spillway is severely spalled below the water line. Large cracks are apparent throughout the portion of the slope which is visible. The concrete spillway crest shows no significant deterioration. There were no noticeable deviations in the crest alignment.

SPILLWAY CREST

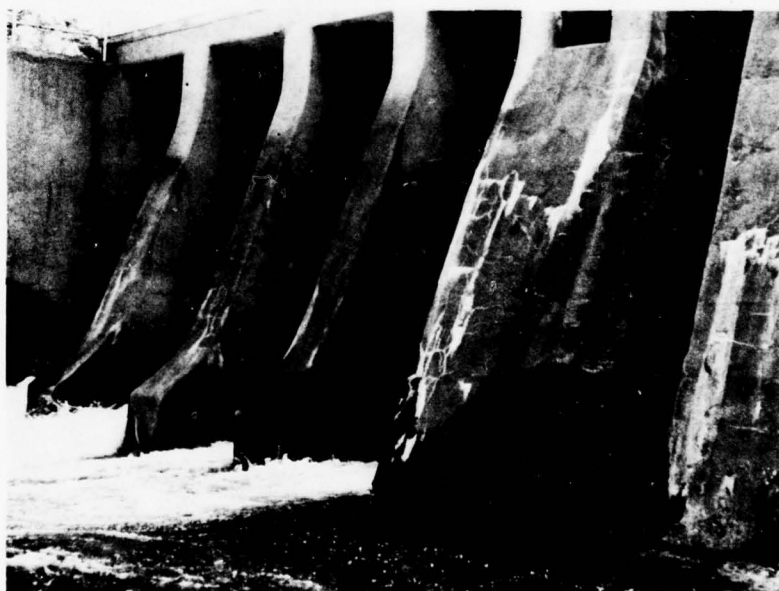
GATE HOUSE PIERS

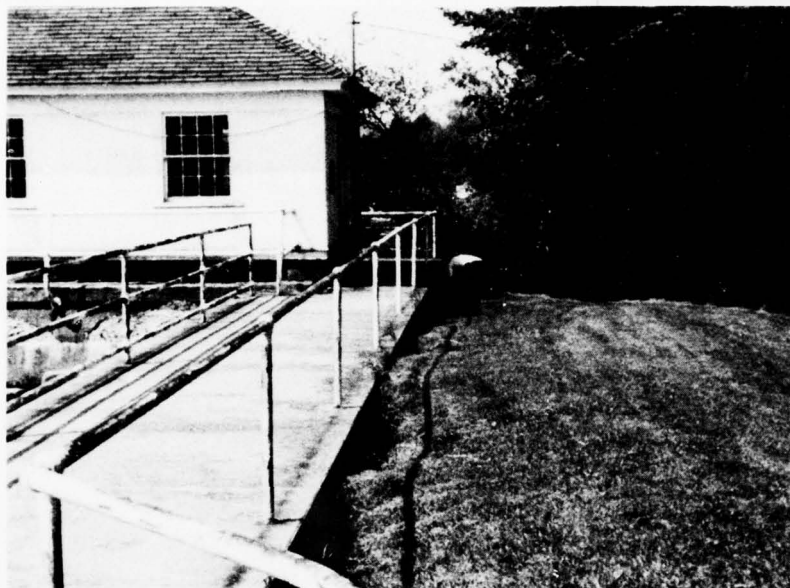
Settlement in the material used to backfill the training wall was noted at several locations along the length of the wall. Indications of erosion were evident at the junction of the embankment with the concrete gravity structure.

Settlement and erosion in the backfill adjacent to the training wall and a sinkhole type depression in the embankment area behind the training wall were noted. These conditions have not been investigated.

SETTLEMENT ALONG TRAINING WALL

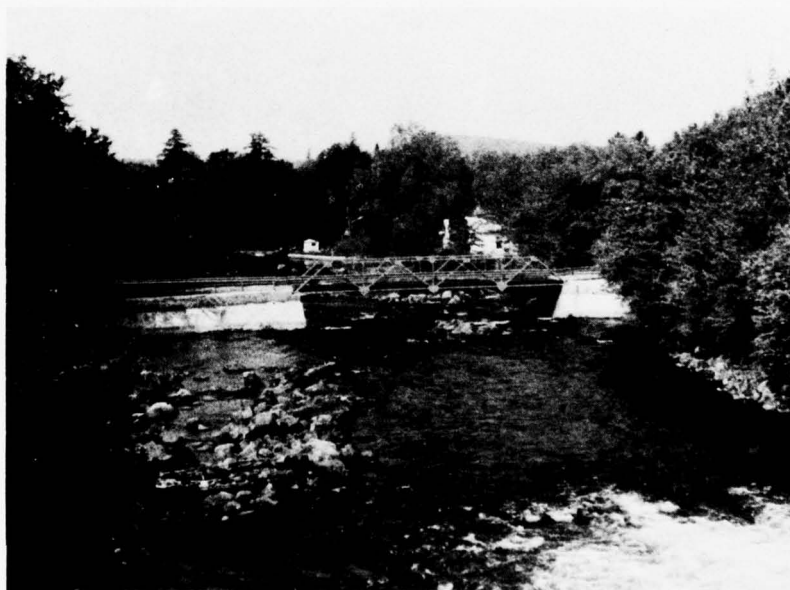
g. Downstream Channel - The channel bottom downstream of the gatehouse is protected with rock set in place; the channel immediately below the spillway is protected by a concrete apron. No indications of erosion were observed at either location although the surface of the concrete slab is noticeably pitted and spalled.

DOWNSTREAM CHANNEL

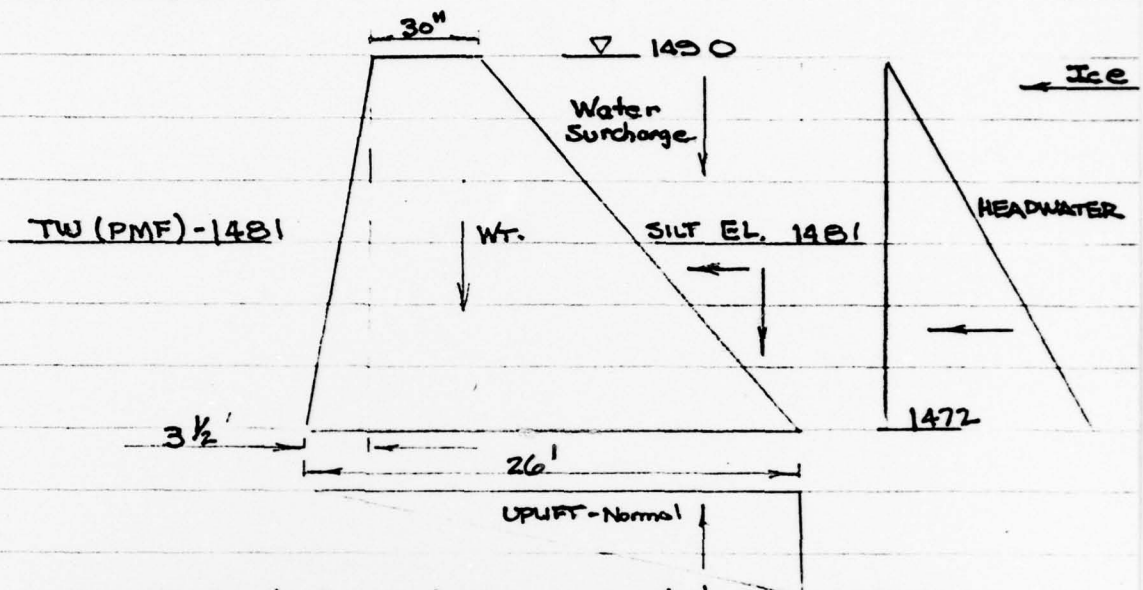
SPILLWAY SECTION

In accordance with Recommended Guidelines for Safety Inspection of Dams the concrete gravity spillway is structurally unstable relative to sliding for all loading conditions. Furthermore, the resultant falls outside the middle third of the base width for the PMF and ice loadings conditions.

LOADING CONDITION	SF - OVERTURNING	SF - SLIDING	BEARING PRESSURES
NORMAL POOL	2.05	1.84	17.8 psi 1.4 psi
PMF	1.90	1.73	20.1 psi 4.6 psi
EARTHQUAKE	1.86	1.29	19.8 psi - .6 psi
ICE LOADING	1.35	1.04	27.2 psi - 8.8 psi
